**MORAN LAKE WATER QUALITY STUDY
&
CONCEPTUAL RESTORATION PLAN**

John Gilchrist & Associates
&
Fall Creek Engineering, Inc.

March 2005

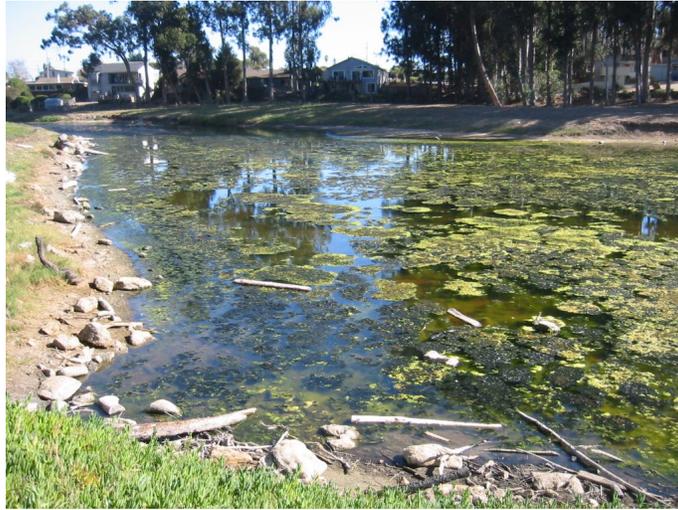
Figure 3.7. Algal Blooms on the Surface of Moran Lake when the Lagoon is Non-Stratified with Little or No Flow from Freshwater or Tidal Inputs – *October 28, 2003*

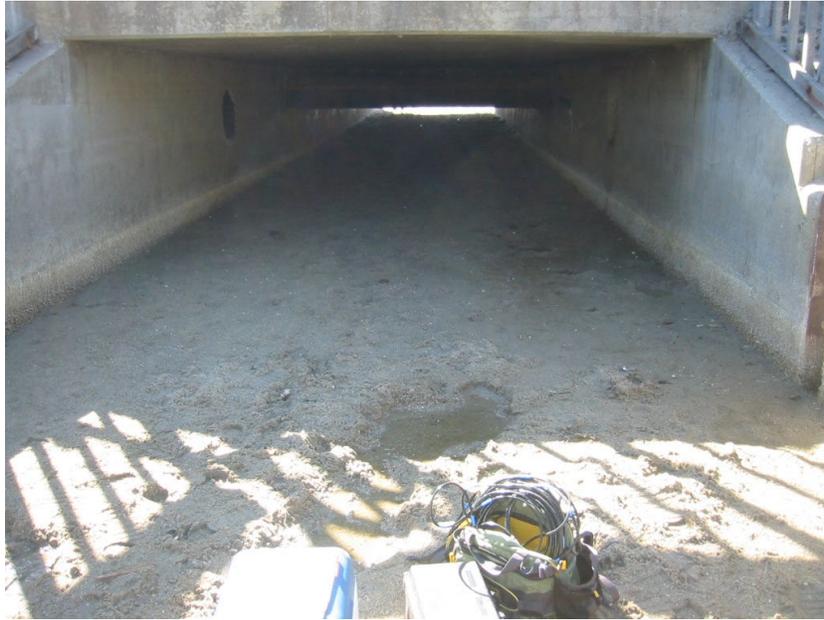
are low occurring typically in later spring. The bar closure limits the interaction between the lagoon and the ocean. During this period, extensive algal blooms were observed on the surface of the lagoon, as shown in Figure 3.7. Figures 3.8 and 3.9 show Moran Lake when the ephemeral bar has formed across the inlet and sand has accumulated inside the box culvert.

Figure 3.9. Moran Lake Box Culvert Closed with Sand– October 28, 2003

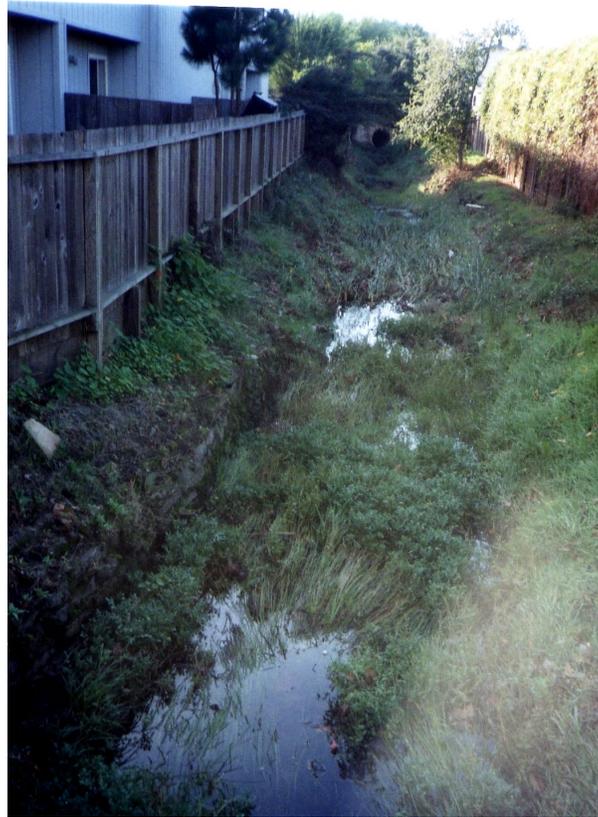
Figure 3.10. Moran Creek—Open Channel with Urban Encroachment

In areas where a narrow above-ground channel exists, widening of the stream corridor to provide for a functional riparian corridor buffer should be considered. High density development and urbanization severely limit restoration opportunities, and any possible stream restoration will be tied to new land use projects. Figure 5.12 presents a conceptual layout and cross section of an above-ground portion of Moran Creek that could be considered for restoration as land use in the area changes. The restoration concept plan suggests widening and reshaping the stream channel to a more natural meandering flow path.

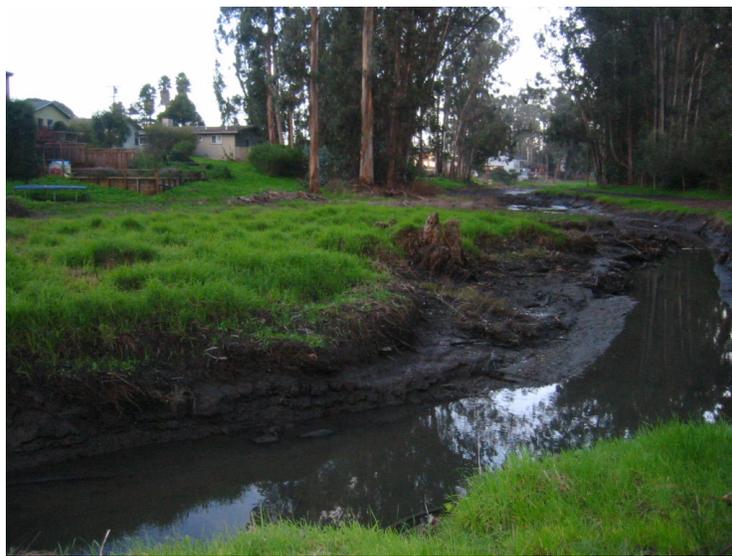
Increased Bank Erosion and Sedimentation. The second change in stream hydrology is an increased frequency of erosive bankfull and sub-bankfull floods. A bankfull flow occurs once every 2 to 2.5 years and has the greatest influence on channel forming features, such as bank height and location and mid-channel bars. The frequency of a bankfull or sub-bank full flow increases in an urban watershed, causing high energy flows that disrupt the channel equilibrium, accelerating bank and channel erosion and sedimentation in the downstream stream and lagoon. Increased bank erosion can also result in costly damage and/or loss of private and public property and infrastructure. Figure 3.13 shows active bank erosion occurring in the upper stream reach of Moran Lake.

Figure 3.13. Channel Erosion in Upper Reach of Moran Lake

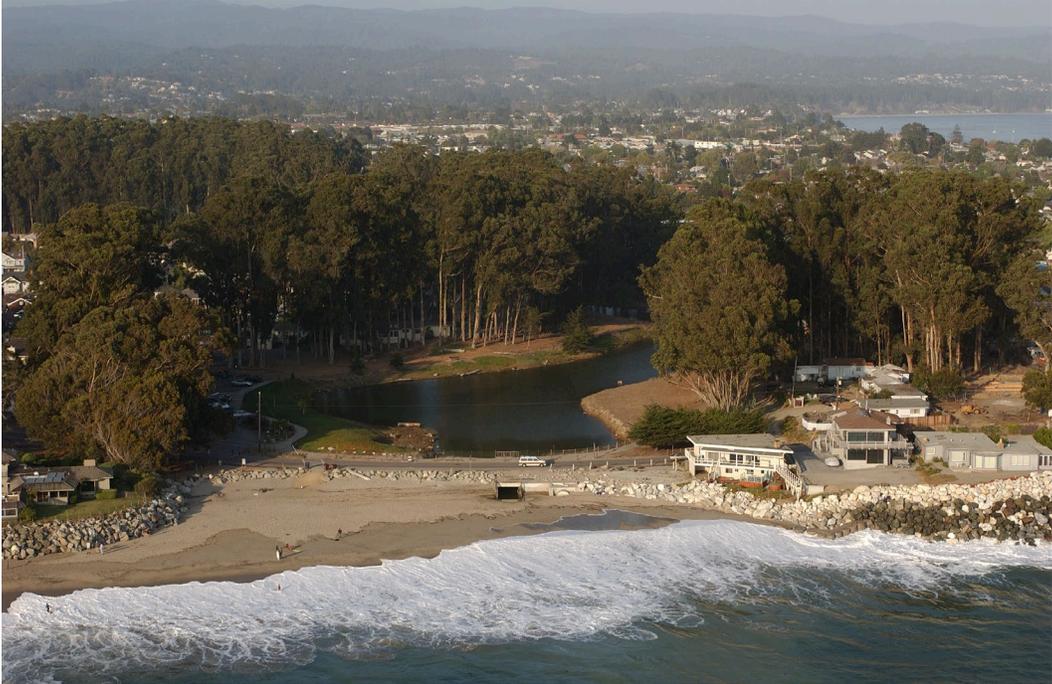
As previously described the lagoon inlet is a box culvert with a fixed bottom as shown in Figure 5.1. The culvert also fixes the depth of the lagoon inlet to -1 foot below mean sea level (msl). This elevation is most likely higher than would naturally occur if the inlet channel was not fixed or the bed of the channel was moveable. If the inlet channel were to be modified as a moveable bed, the depth of the inlet would change both seasonally and annually depending on storm flows and wave action affecting littoral drift and ephemeral bar formation. It is expected that the “equilibrium” elevation of the new channel would be deeper than the current elevation.

Figure 5.1. Moran Lake Outlet (September, 2002)

Replacing the box culvert with an arched bottomless culvert or clear span bridge would not impede the lagoon inlet to a fixed depth, which may increase tidal flushing and the frequency of lagoon opening and closing. Figure 5.3 presents examples of a bottomless arched culvert used to restore stream and lagoon functions in sensitive habitat areas. However, limited beach profiling information collected during the period of study suggest that the inlet configuration at Moran Lake may function similar to an unimpaired lagoon system, with seasonal fluctuations of the ephemeral bar on the Moran Lake beach controlling the connection of the lagoon with the ocean.

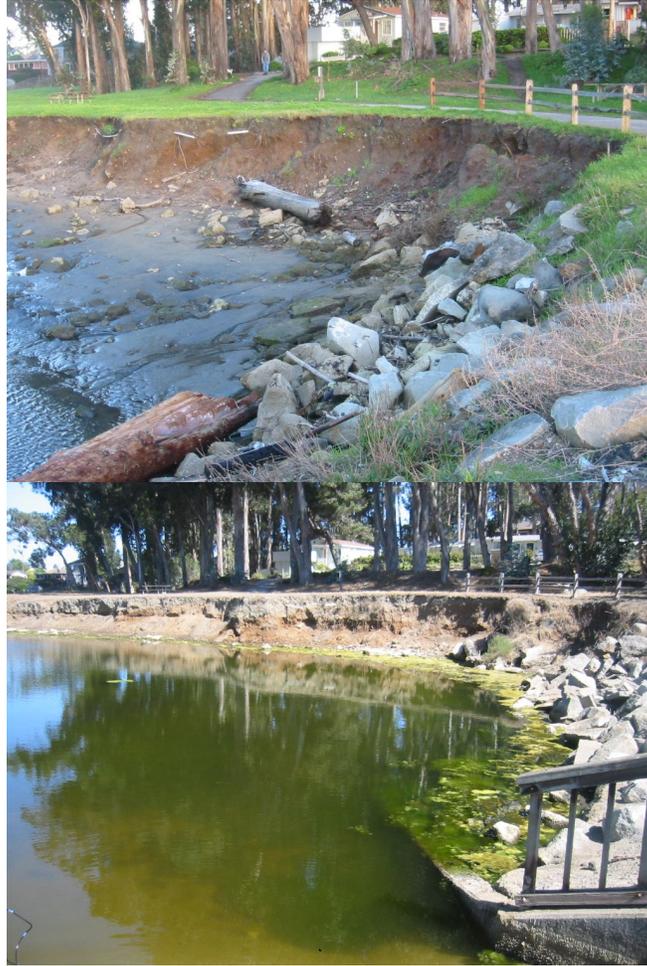
Due to urban development adjacent to the lake wetlands that once likely existed along the edges of Moran Lake have been destroyed. Concurrent with the removal or alteration of fringe wetlands, diminished vegetation and increased flows from a mostly impervious watershed have resulted in failing banks at some locations along the shore of the lagoon. The most notable failure has occurred on the lower east lagoon bankslope. Figure 5.7 shows the failing bank and its proximity to a frequently accessed bike trail. (A portion of the slope near the lagoon outlet has been reinforced with riprap.)

**Figure 5.7. Eroding Bank on the Eastern Shore of Moran Lake
(Photos taken on September 11, 2003 (lower) and February 2, 2004)**

rebuilt in a westerly direction recapturing the bank lost to erosion. Figure 5.8 is a cross section showing a conceptual design of the restored bank.

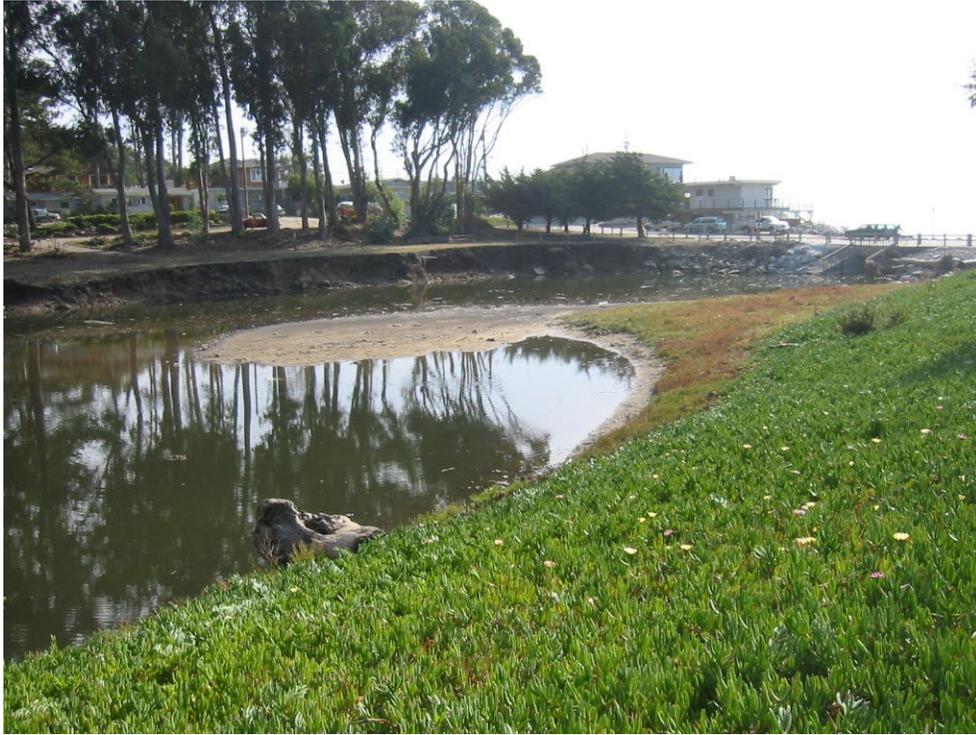
Figure 5.9. Possible Location for Revegetation with Native Plant Species (Area presently covered almost exclusively with non-native ice plant)

exotics removal and native plant installation would also provide an opportunity to involve volunteers from the Moran Lake community.
