**MORAN LAKE WATER QUALITY STUDY
&
CONCEPTUAL RESTORATION PLAN**

John Gilchrist & Associates
&
Fall Creek Engineering, Inc.

March 2005

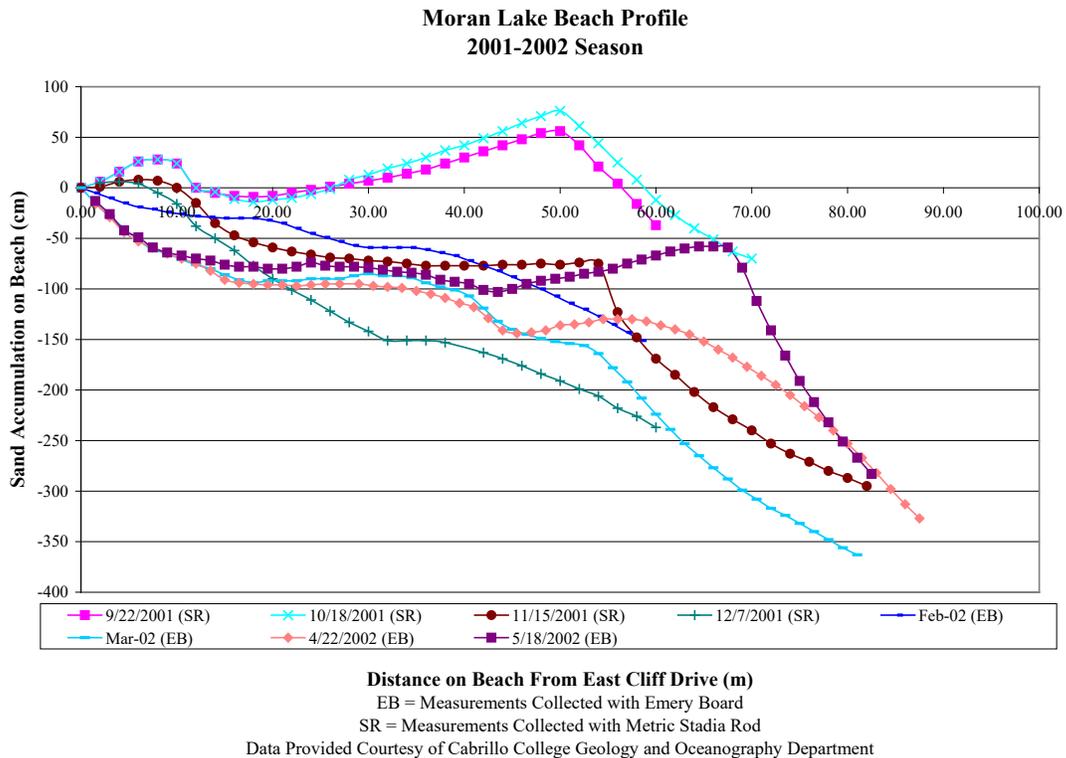
Figure 3.1 depicts how the sand on the beach fluctuates seasonally. Beginning in the late winter and early spring sand accumulates on the beach and forms an ephemeral bar across the Moran Lake inlet. The elevation and accumulation of sand on the beach continues through spring until late fall, with saltwater associated with high tides occasionally overtopping the ephemeral bar and entering Moran Lake. Based on discussions with Dave Schwartz, Oceanography Professor at Cabrillo College, in some years the elevation of sand on the beach exceeds the elevation of East Cliff Drive, with the amount and steepness of sand on the beach reaching its peak in the fall months. The graphical data also shows how the first large storm in the late fall or early winter, combined with large wave energy, erodes the ephemeral bar and opens Moran Lake to the ocean. Depending on storm and tide patterns, sand elevations fluctuate throughout the winter. During this time the lagoon bar remains open to the ocean, until early spring when the ephemeral bar closes.

Figure 3.1. Moran Lake Beach Profile, 2001-2002 Season

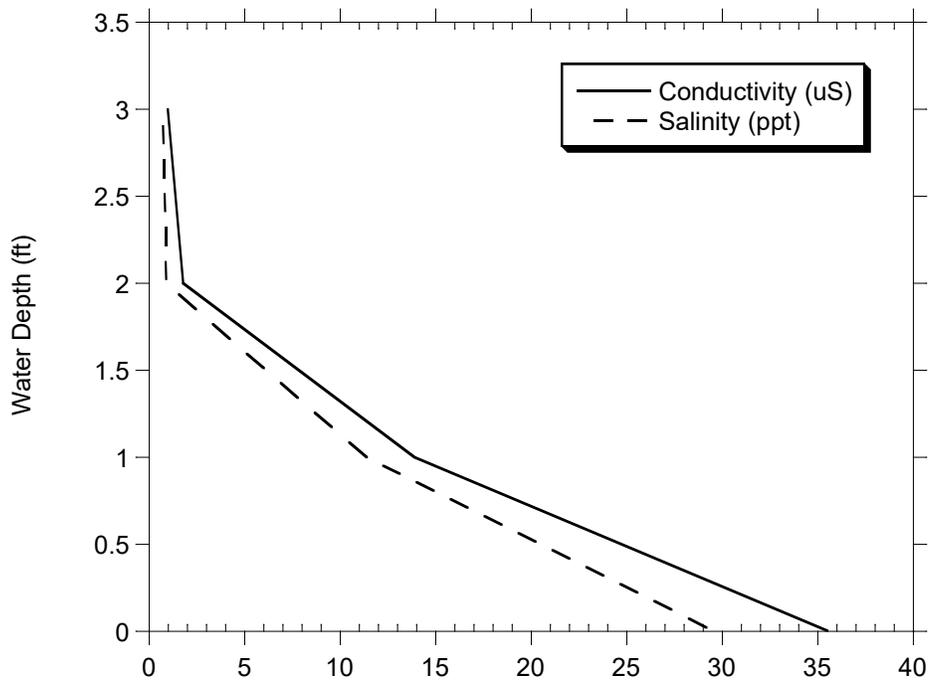
Highly Stratified Conditions. A highly stratified non-mixed regime was observed within Moran Lake during the first flush event of the season. At the time of the event on October 31, 2003, the ephemeral bar at the lagoon inlet had not been breached and limited interaction between the lagoon and ocean was possible. Rainfall-runoff entering the lagoon created a lens of freshwater above higher density saltwater that had accumulated during the summer months. The density difference between the fresh and saltwater and the lack of physical mixing by tides or winds prevented significant mixing between the two layers. Water quality measurements of salinity and conductivity, indicators of salt or freshwater content, clearly show the stratification of the salt and freshwater. Figure 3.2 shows the lagoon under highly stratified conditions with the transition between saltwater at the lagoon bottom and freshwater at the top. At the lagoon bottom from zero to six inches the water has a salinity of 29.6 parts per thousand (ppt) and a conductivity of 35.6 microSemens (mS). At the water surface the fresh stormwater has a salinity of 0.7 ppt and a conductivity of 0.96 mS.

Figure 3.2. Summary of Conductivity and Salinity Measurements Collected During the First Flush Event on October 31, 2003 from Site 2

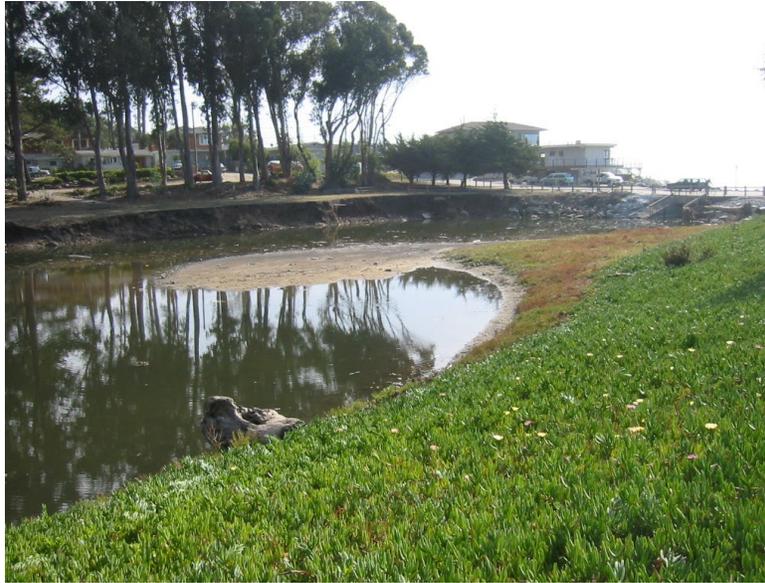
Partially Mixed Condition. A moderately stratified mixing regime was observed when the ephemeral bar breached, and the beach profile was not low enough to allow a

Figure 3.3. Moran Lake After Ephemeral Bar has Breached and Lagoon is Partially Mixed – November 12, 2003

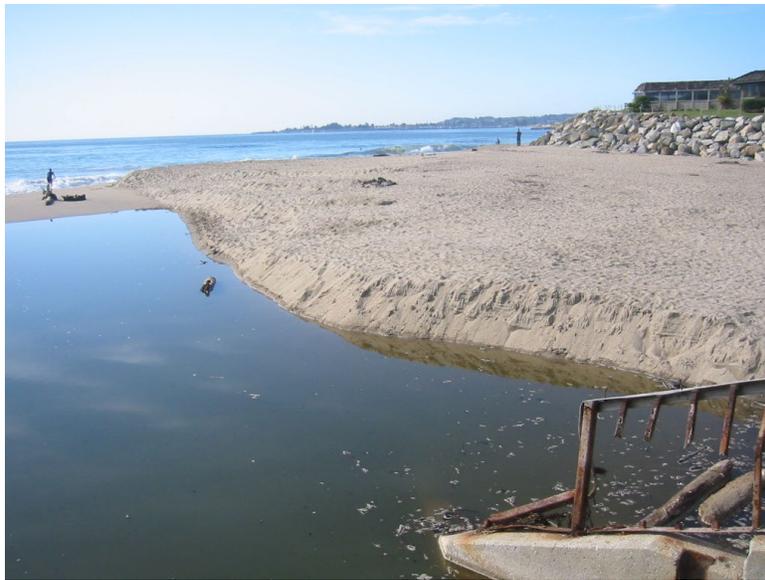
Figure 3.4. Moran Lake Beach After Ephemeral Bar has Breached and Lagoon is Partially Mixed – November 12, 2003

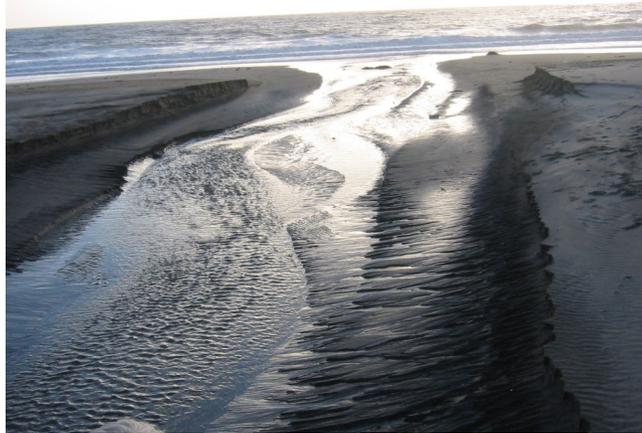
elevation (invert) of the box culvert. When the sand bar drops below the invert of the culvert stream flow does not backup and pond but flows through. In this condition the lagoon is functioning as a stream channel. When the water levels were low in the lagoon, it revealed fine-grained silt and clay sediments on the bottom of lagoon basin. Figures 3.5 and 3.6 shows Moran Lake and the channel on the beach during a low tide when the water in the lagoon is freshwater.

Figure 3.5. Lagoon Outflow Non-Stratified with Primarily Freshwater Flow – February 2, 2004

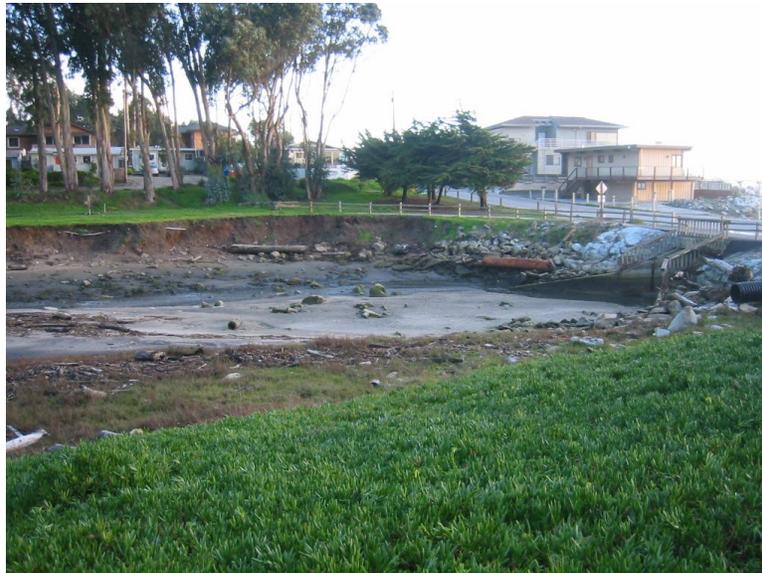
Figure 3.6. Moran Lake when the Lagoon is Non-Stratified with Primarily Freshwater Flow – February 2, 2004

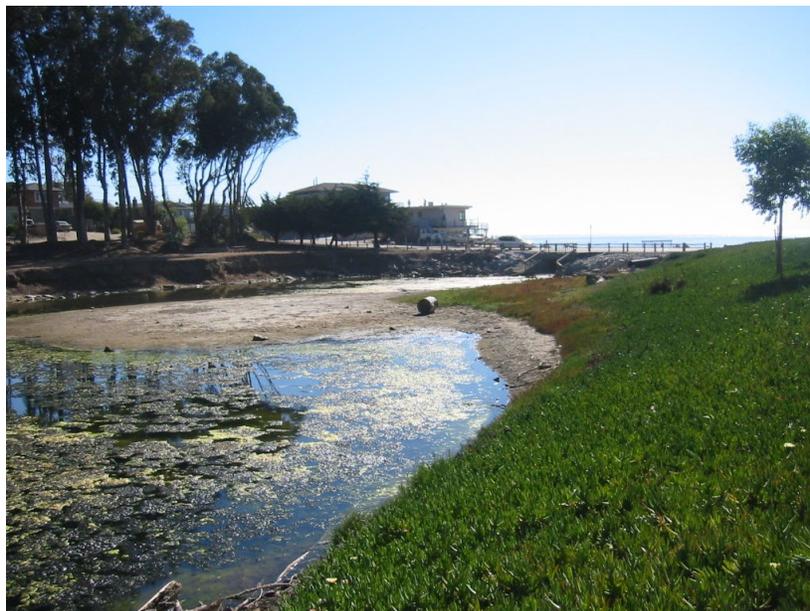
Figure 3.8. Moran Lake when the Lagoon is Non-Stratified with Little or No Flow from Freshwater or Tidal Inputs and the Lagoon is Primarily Filled with Saline Water– *October 28, 2003*

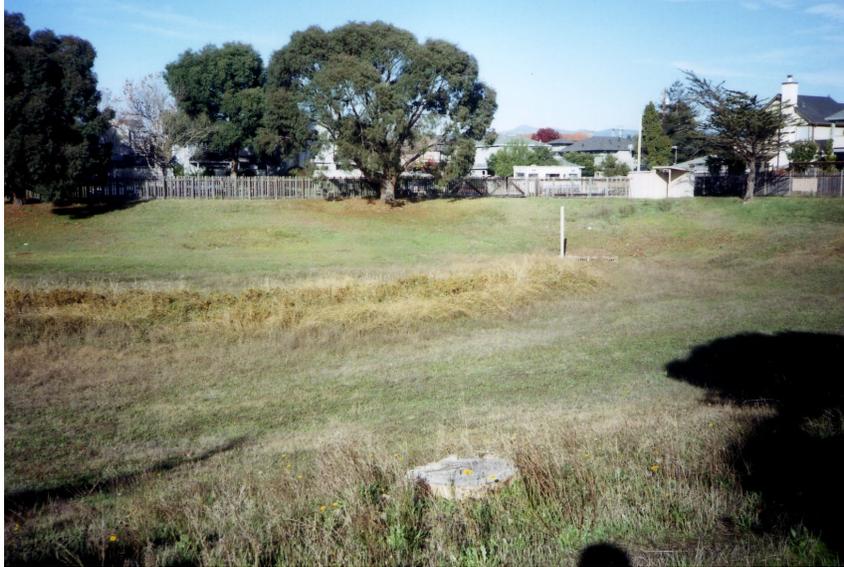
Even with the reduction of the watershed drainage basin, continued urbanization has resulted in localized flooding in some portions of the watershed. To mitigate flood problems in the lower watershed, the County constructed the 38th Avenue Stormwater Detention Basin (Basin), as shown in Figure 3.11. The Basin is located on the southeast corner of the intersection of Brommer Street and 38th Avenue, and receives runoff from approximately 235 acres in the upper Moran Lake watershed. The Basin is designed to temporarily store runoff resulting from events that exceed the 150 cubic feet per second (cfs) capacity of the downstream culvert.

Figure 3.11. 38th Avenue Stormwater Basin

Based on discussions with local residents some reaches of the stream continue to experience localized flooding. These events are primarily attributed to older infrastructure projects, such as undersized culverts that have not been replaced to accommodate increased runoff rates. Ongoing development in the watershed continues to contribute to these problems.

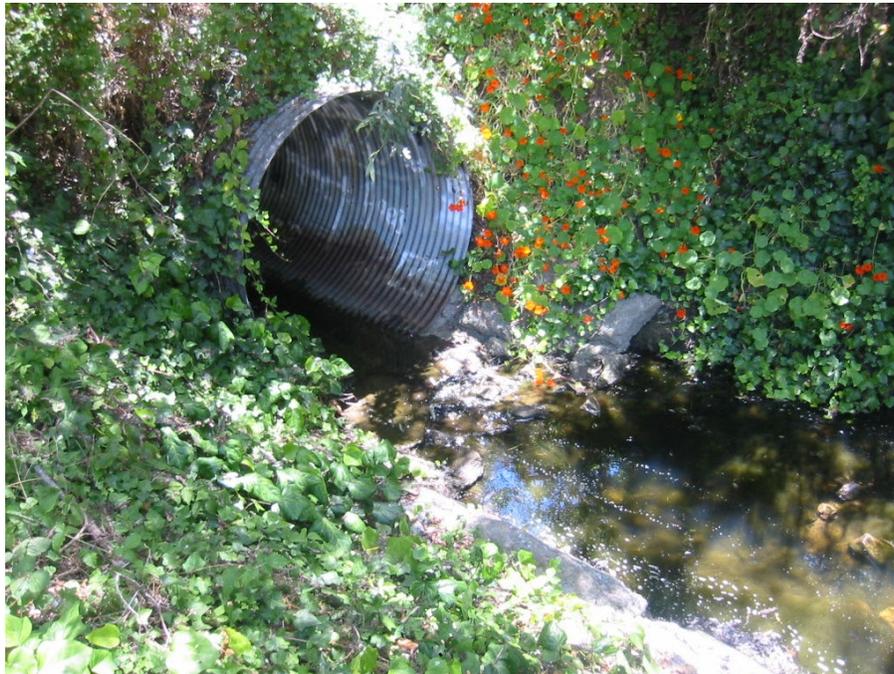
Site 4. Site 4 is located on Moran Creek east of 30th Avenue, approximately three feet downstream of a culvert which is located between 30th and 34th Avenues, as shown in Figure 4.2.

Figure 4.2. Sampling Location #4, Moran Creek East of 30th Avenue

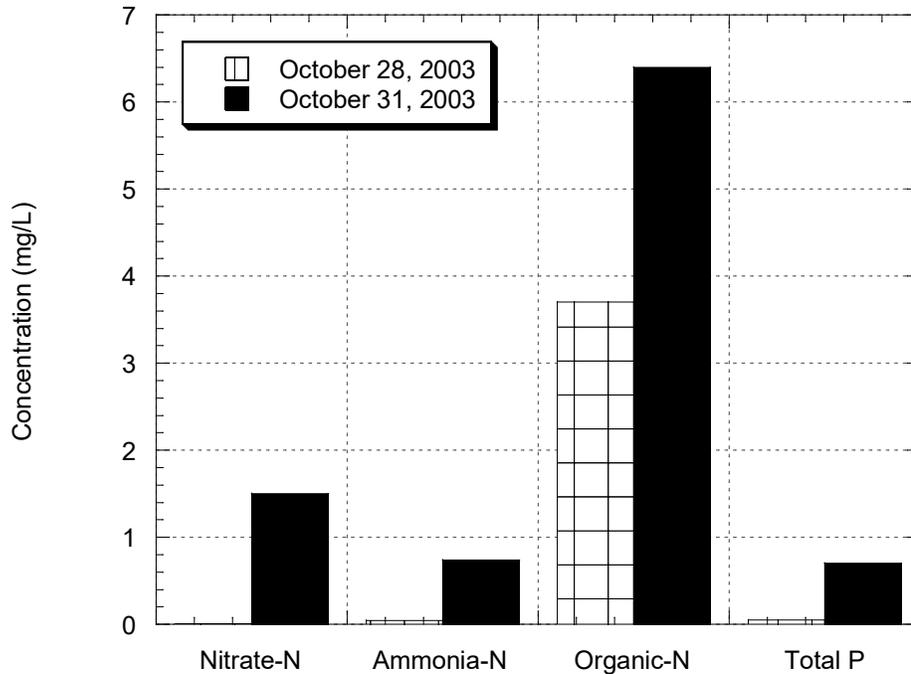
The highest concentrations of total phosphorus, nitrate-N (NO_3^-), ammonia-N (NH_3), and organic-N were measured during the first flush sampling event on October 31, 2003. The concentrations are significantly higher than those measured on October 28, 2003, just three days before the first significant rainfall event of the season, as shown at Site 2 in Figure 4.7. The increased concentrations are likely a result of urban pollutants, such as waste products and lawn fertilizers, which were transported into the lagoon by storm water runoff.

Figure 4.7. Nutrient Concentrations at Site 2 on October 28 and October 31, 2003

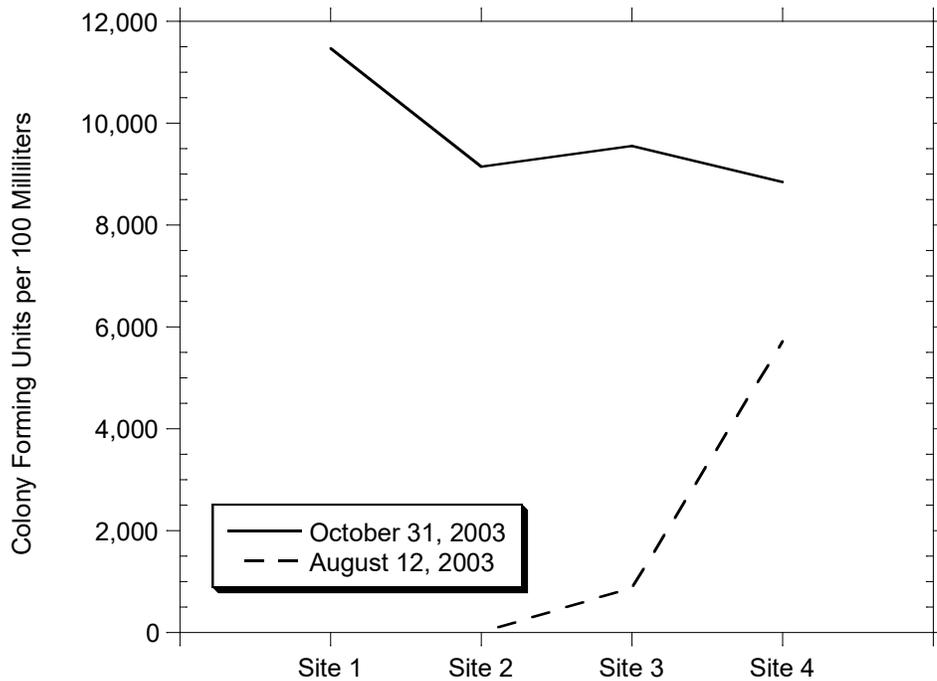
The highest total and fecal coliform counts were recorded during the first flush sampling event on October 31, 2003, and the highest values on that day were recorded at Site 1, as shown in Figure 4.8. Site 1 receives storm water runoff from Moran Creek as well as from a storm drain outlet under East Cliff Drive, which likely contributed to the increased fecal coliform counts at this location. The highest counts prior to October 31, 2003, sampling events, were recorded at Site 4 in Moran Creek, as shown in Figure 4.8 for samples collected on August 12, 2003.

Figure 4.8. Results of Fecal Coliform Counts on August 12 and October 31, 2003

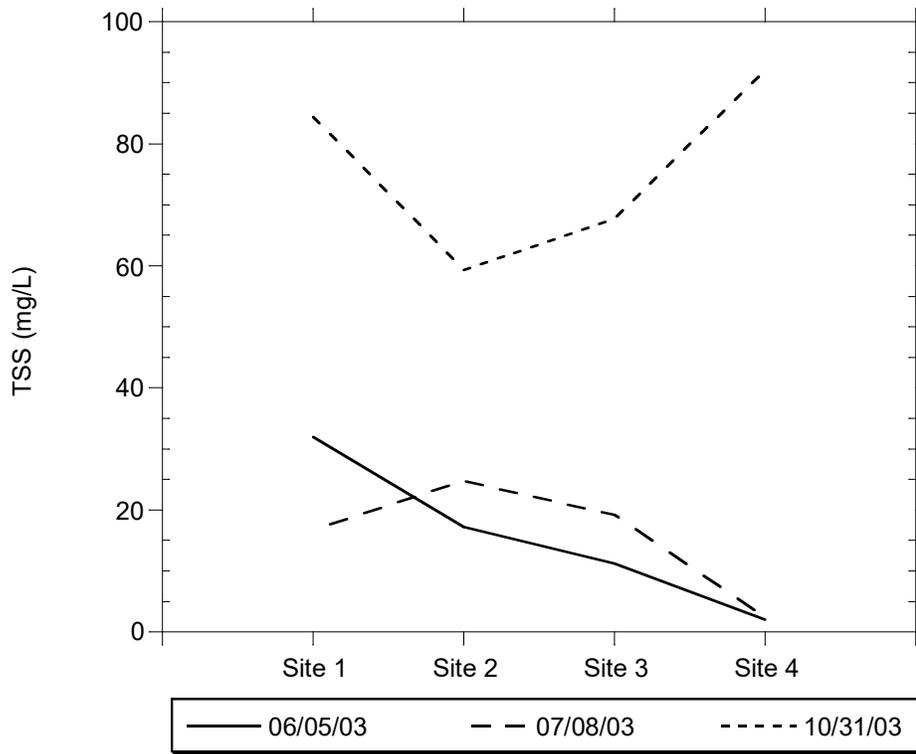
Samples collected during the summer months, June and July, represent conditions during which the majority of TSS is algae floating in the water column. During this period the TSS concentrations ranged from approximately 5 mg/L to 35 mg/L. Samples collected in October during the first flush event had substantially higher TSS concentration ranging from 60 to 92 mg/L. The higher TSS concentrations are attributed to storm water runoff entering the lagoon from Moran Creek, local drainage and East Cliff Drive. Figure 4.9 shows the results of three representative sampling events collected from the four sampling sites within Moran Lake and analyzed for TSS.

Figure 4.9. Total Suspended Solids Concentrations

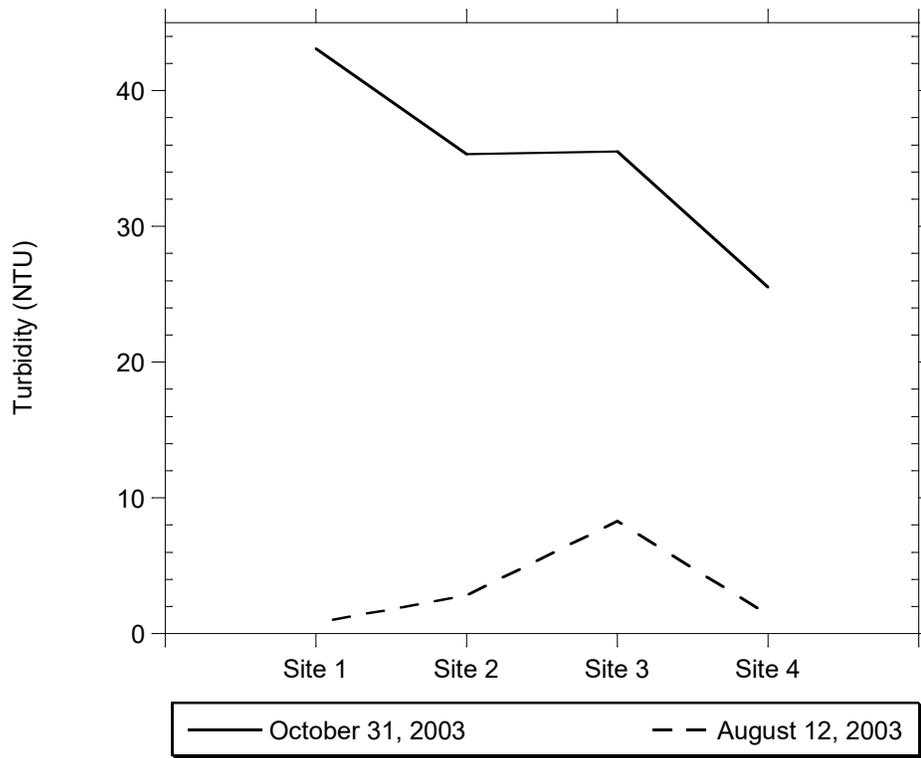
Turbidity measurements across the four sampling sites did not vary significantly, though overall Site 3 appeared to have higher readings than the other two locations. Site 3, in the

upper lagoon, could have higher turbidity measurements due to the accumulation of organic debris at this location as well as the proximity to a storm drain outfall. The highest turbidity measurement at each sampling location was recorded during the first flush sampling event. The high readings occurred because of high energy storm water flows that introduced suspended sediments into the lagoon and also re-suspended sediment and organic debris from the lagoon bottom. Figure 4.10 shows the results of turbidity measurements collected from the four sampling locations on August 12, 2003, which depicts the increased readings at Site 3 during the summer months, and the increased turbidity measurements observed during the first flush on October 31, 2003.

Figure 4.10. Turbidity Measurements taken on August 12th and October 31st 2003

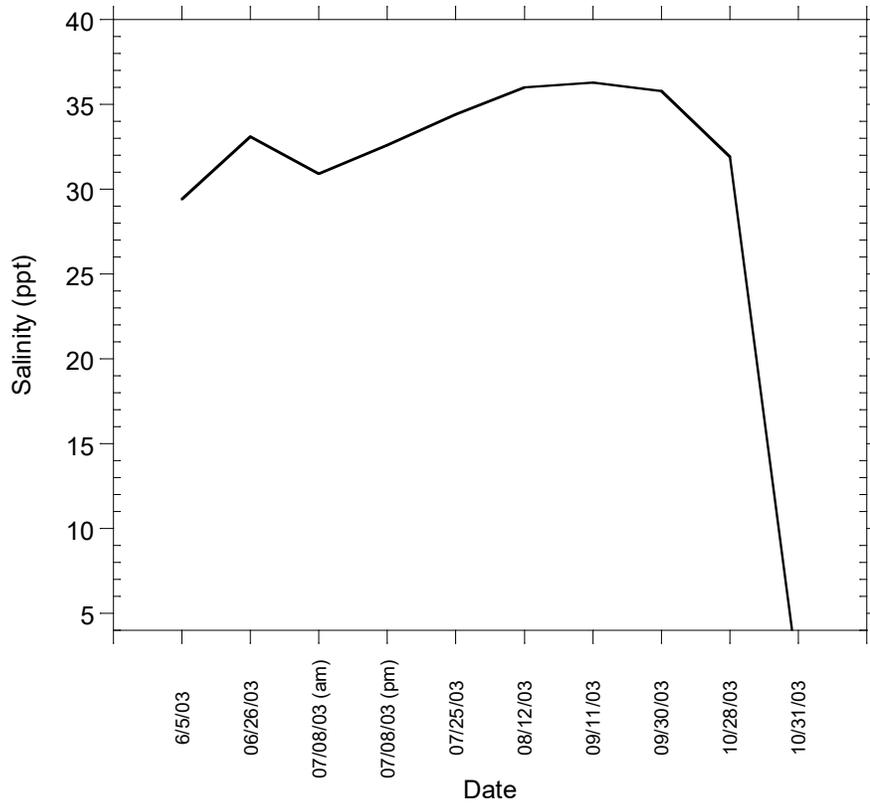
Salinity in the lagoon increased from June to October, when the lagoon opening was closed and evaporation increased salt concentrations in the lagoon. The highest salinity measurements were recorded in August and September, and were in excess of 35 ppt, approaching hyperhaline conditions. Figure 4.11 shows increasing salinity measurements taken on the surface of the lagoon at Site 1. Salinity decreased rapidly during the first flush, when high freshwater flows entered the lagoon from Moran Creek. The decreased salinity on this date was recorded due to the freshwater lens formed on the surface of Moran Lake from Moran Creek and other surface water drainages adjacent to the lagoon that contribute storm water runoff.

Figure 4.11. Salinity Measurements Collected at Site 1

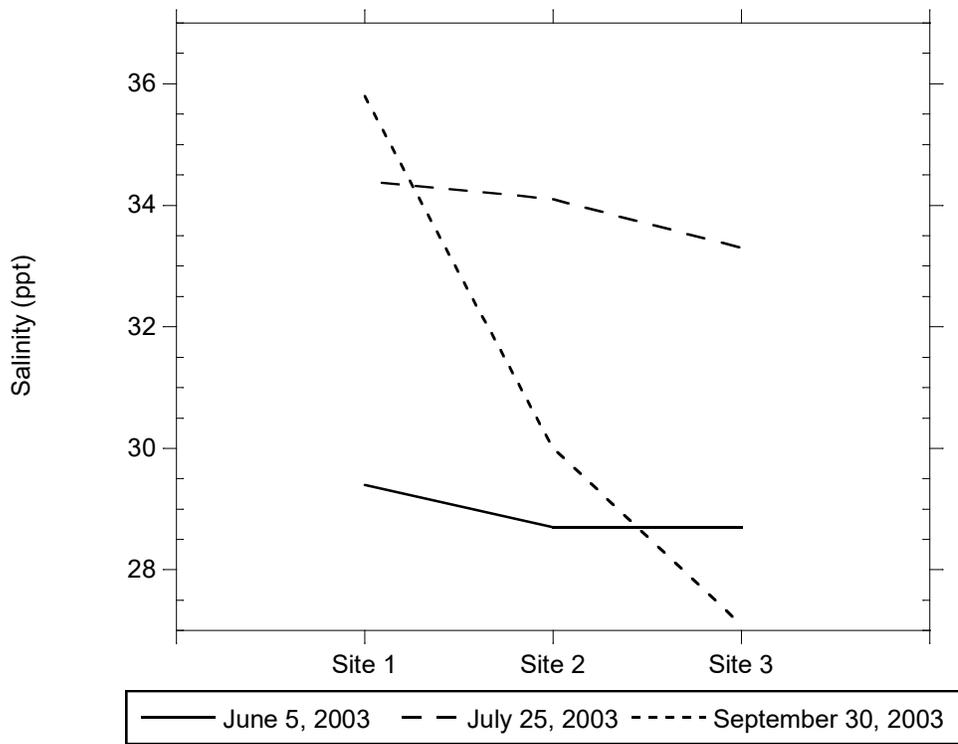
Salinity measurements taken at the surface were generally less than measurements taken at depth within the lagoon. This phenomenon indicates that a warm wedge of saltier water forms in the deeper water in the lagoon. At the beginning of the sampling, in June, salinity measurements were generally uniform across the entire lagoon. Beginning in August and continuing into October, the salinity measurements generally decreased from the lagoon inlet towards the upper lagoon. All salinity measurements taken at Site 4 were less than or equal to 0.5 ppt, indicating the site was measuring freshwater flows from Moran Creek and is above any salinity influences from the lagoon. Figure 4.12 shows surface water salinity measurements collected during three sampling events within the lagoon at Sites 1, 2, and 3, showing the trend towards decreasing salinity in the upper lagoon during late summer.

Figure 4.12. Salinity Measurements on June 5th, July 25th, September 30th, 2003

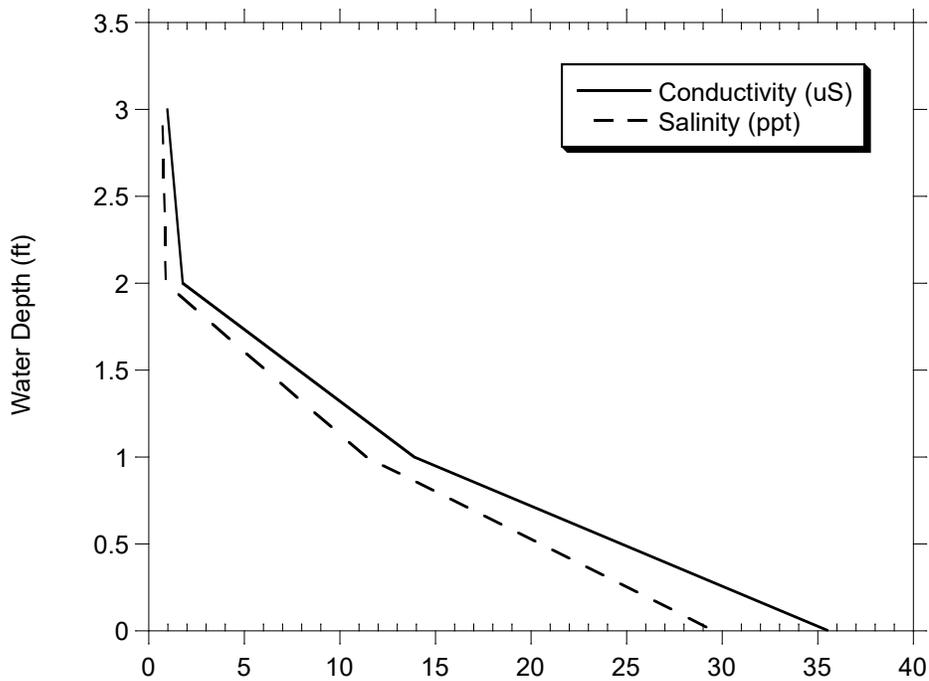
The lowest electrical conductivity measurements were recorded at Site 4, in the freshwater of Moran Creek. The highest measurements were recorded during August and September at Site 1, where near-hyperhaline conditions were observed. Very little variation in electrical conductivity measurements between each of the three sampling locations within the lagoon was observed. Electrical conductivity measurements did generally increase with depth at each of the sampling locations within the lagoon, another indication of the warm lens of saltier water on the lagoon bottom. Figure 4.13 shows the transition of salinity and conductivity measurements with depth collected from Site 2 on October 31, 2003.

Figure 4.13. Salinity and Conductivity Measurements at Site 2 on October 31st 2003.

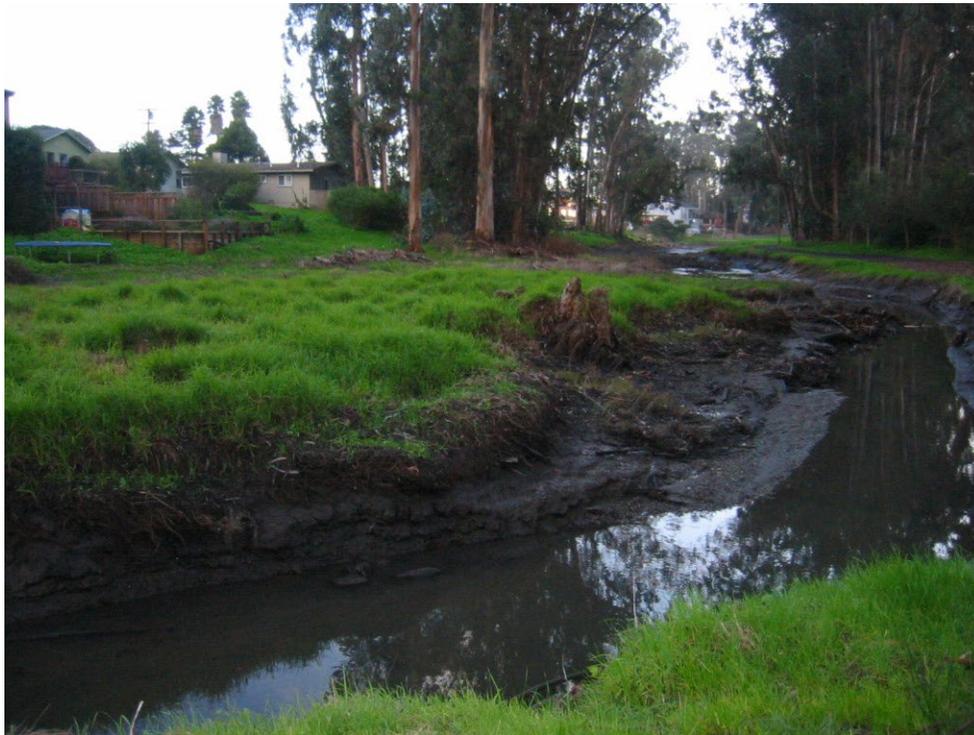
Historical fill practices have significantly impacted Moran Lake by diminishing over forty percent of the surface area of the lagoon. This has reduced the volume and depth of the lagoon, which has affected the lagoons ability to assimilate or dilute pollutants entering the lagoon during winter runoff events. Expanding the effective surface area of the lagoon would be beneficial. However, increasing the lagoon area is constrained by development, competing land uses and sensitive species protection (monarch butterfly habitat).

Figure 5.4. Public Land in Upper Lagoon Identified for Possible Wetland

A potential opportunity to create an expanded wetland on public lands within the upper lagoon has been identified. Wetlands have been shown to be effective filters of urban stormwater pollutants, and could reduce the concentration of nutrients, solids, metals and other constituents entering Moran Lake. Figure 5.4 shows County owned land that may be suitable for development of a wetland.

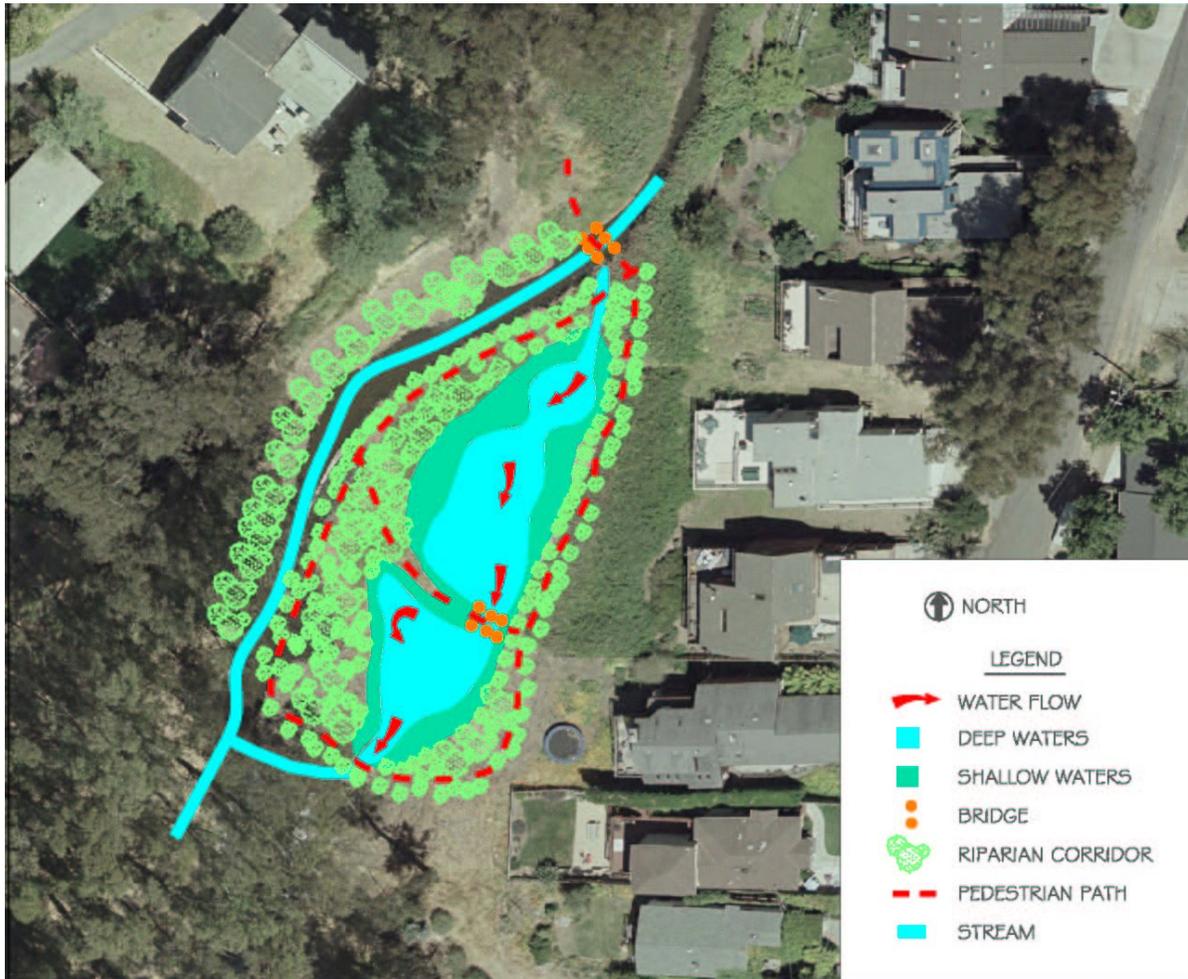
Figure 5.5. Conceptual Layout of Proposed Wetland in the Upper Lagoon Area of Moran Lake

A wetland in the upper lagoon could potentially improve water quality and improve wildlife foraging and nesting habitat within the lagoon. Construction of a wetland would also develop more natural hydrologic conditions within the lagoon by restoring a wetland area where it likely existed historically. Figures 5.5 and 5.6 present a conceptual layout and cross section of how a wetland in the upper lagoon could be constructed. The wetland could incorporate walking trails for public access, as well as multiple pools with varying depths to maximize pollutant removal and habitat diversity.

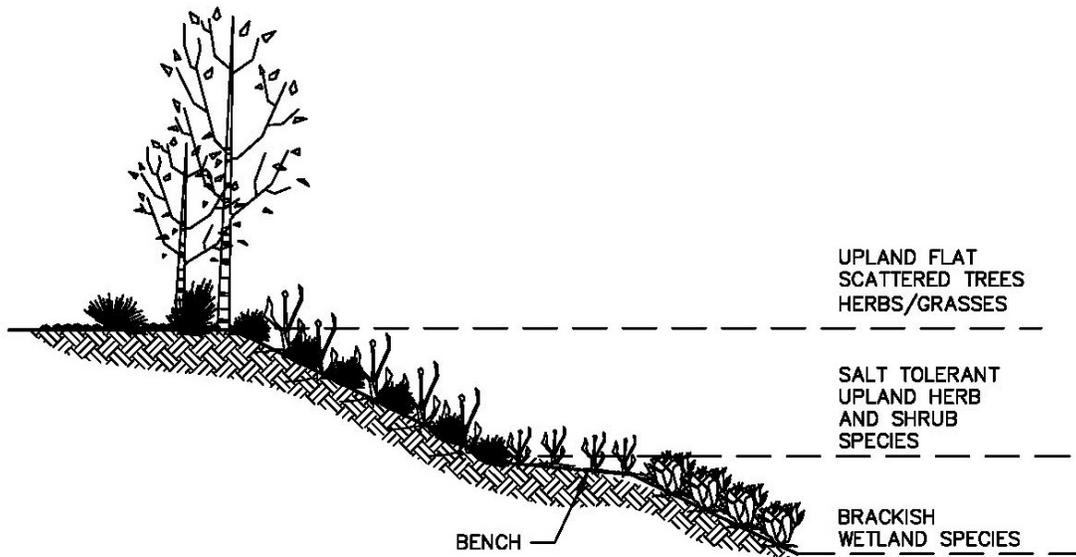
Figure 5.8. Cross-Section showing the Conceptual Layout of Restored Bank on Eastern Shore of Moran Lake

A conceptual bank stabilization project is proposed utilizing a biotechnical approach to stabilize the bank to protect the bicycle path and improve wetland habitat along the fringe of the lagoon. The conceptual plan would regrade the existing steep bank to a 2.5:1 to 3:1 slope from the crown of the slope and incorporate a low terrace or bench at the toe that can be planted with native brackish wetland species. The upper bank could be planted with salt tolerant upland herb and shrub species with the upland flat planted with scattered trees, herbs, and grasses. This design would have the benefits of creating additional wildlife habitat while reducing or eliminating the current rate of bank erosion. In order to protect the bicycle path and adjacent upland, the restored bank may need to be

rebuilt in a westerly direction recapturing the bank lost to erosion. Figure 5.8 is a cross section showing a conceptual design of the restored bank.

Further engineering analysis of this project may indicate the need to incorporate some additional structural protection (such as a crib type wall to reduce the slope of the bank) or hardscape (such as riprap at the toe of the bank to protect the toe of the bank from excessive scour) combined with the vegetative treatment.

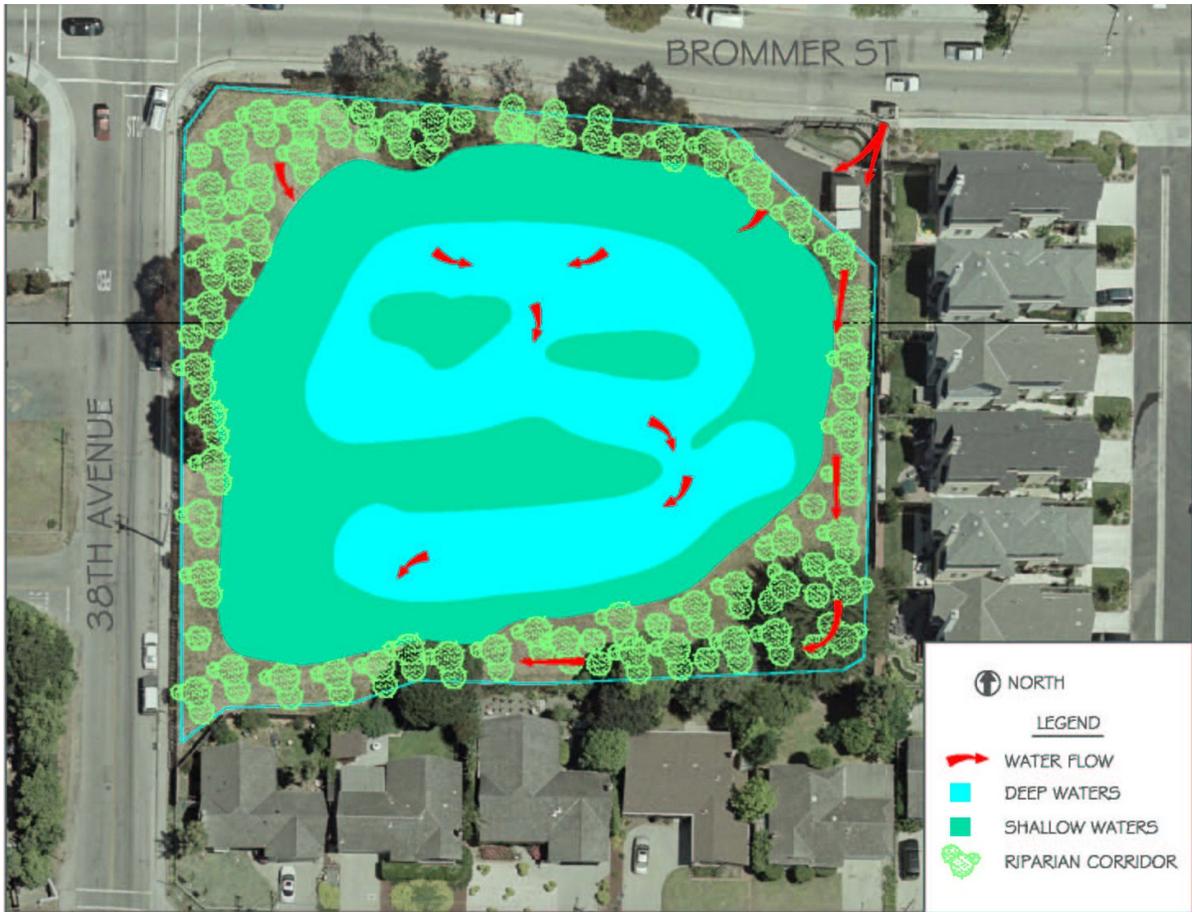
Figure 5.11. Conceptual Layout of 38th Avenue Detention Basin Modified to Include a Stormwater Wetland

The existing storm water detention basin located at 38th could potentially be modified to function as a storm water treatment wetland during low flow events. The existing detention basin could be reconfigured to divert runoff through the wetland during low flow periods. During high flow events the wetland would be temporarily inundated, allowing it to capture nutrients, bacteria and heavy metals contained in urban runoff. The wetland could improve surface water quality entering the lower reaches of Moran Creek and ultimately the lagoon. The wetland could also be designed to provide wildlife

habitat. A conceptual layout of how the 38th Avenue detention basin could be reconfigured to a low flow stormwater wetland is presented in Figure 5.11.

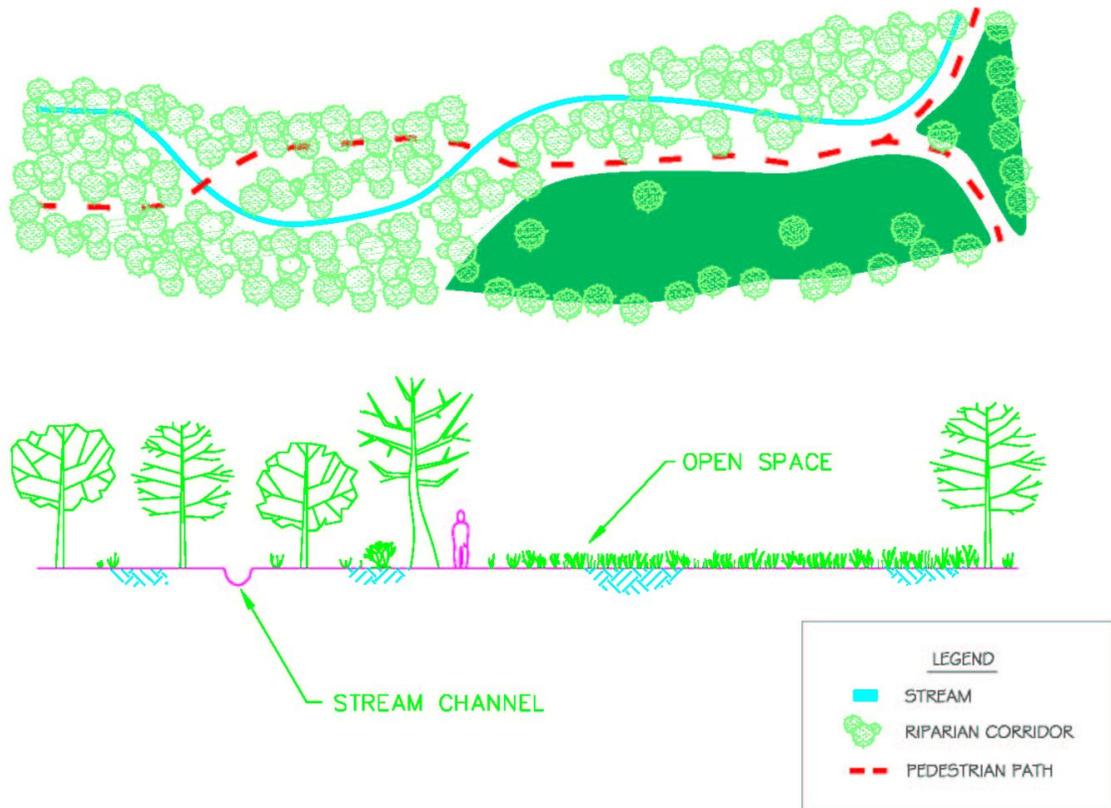
Figure 5.12. Conceptual Layout of Moran Creek Stream Restoration

In areas where a narrow above-ground channel exists, widening of the stream corridor to provide for a functional riparian corridor buffer should be considered. High density development and urbanization severely limit restoration opportunities, and any possible stream restoration will be tied to new land use projects. Figure 5.12 presents a conceptual layout and cross section of an above-ground portion of Moran Creek that could be considered for restoration as land use in the area changes. The restoration concept plan suggests widening and reshaping the stream channel to a more natural meandering flow path.
